**PROGRESS: 100% - COMPLETED**  
CZECHIA/SEDEC UND PRČICE/2017-18

## RENOVATION OF A HISTORIC BRIDGE

### Sedlec-Prčice bridge

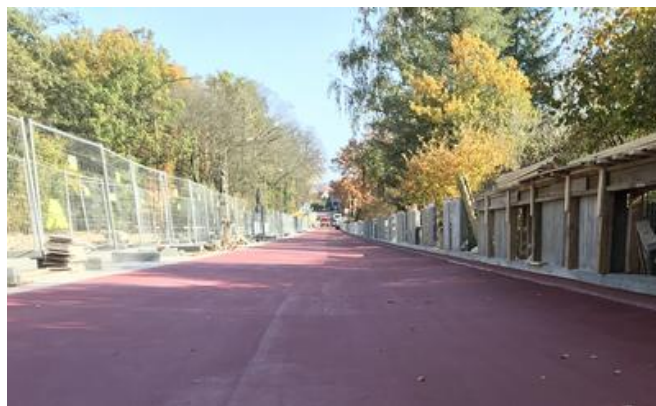
Caption: A new road surface was applied on the bridge and its ageing concrete rails were replaced. Source: PORR

PORR was able to extend its lifespan by replacing the bridge equipment. The road surface and, above all, the ageing reinforced concrete rails were replaced and fully functional bridge draining systems were installed. This work involved installing new parapets, bituminous waterproofing and new composite panels, while the natural stone masonry was also

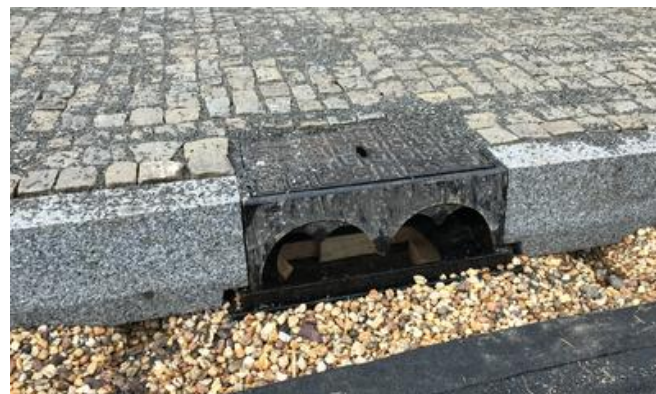
Caption: Even the kerb drainage systems needed to correspond to the specifications set down by the Monument Care Department.  
Source: PORR

Following installation of the sealing system, kerb drainage points were installed at 10m intervals; like the granite waterspouts, they had to be approved by the Monument Care Department. The same applied to the reinforced concrete rails erected on top of the reinforced covers. A prototype was presented to the Monument Care Department to demonstrate the steel rod interiors. PORR realised a three-layer asphalt carriageway between the kerbs. The pavements feature natural stone paving in a sand bed, with a transverse gradient of 2.5%.

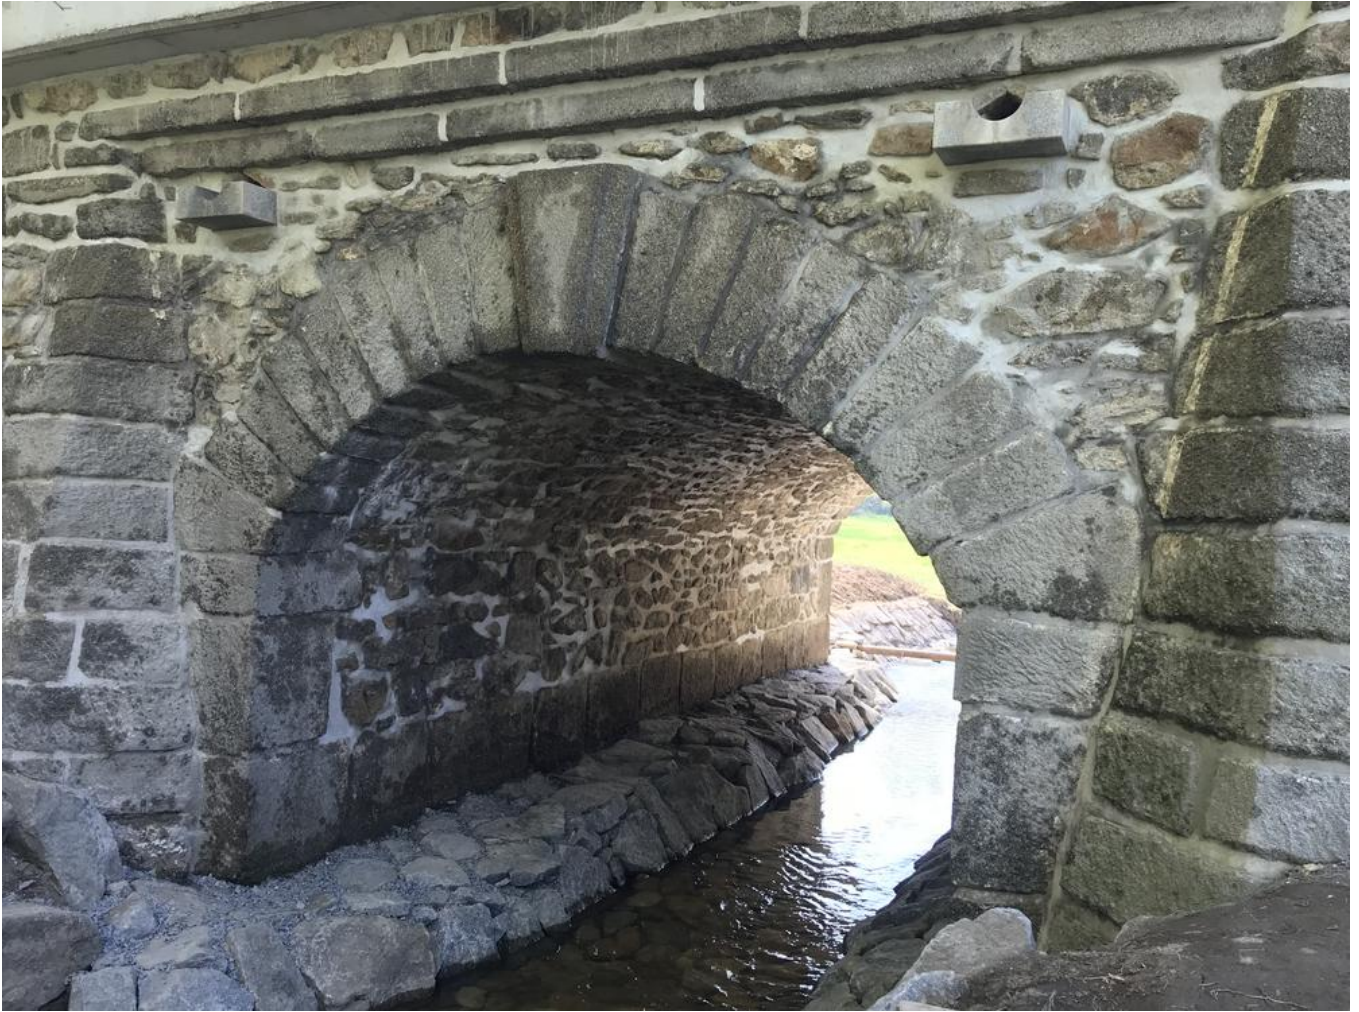
The visible areas of jointing were neither smoothed nor treated in any other way. Missing parts of the natural stone masonry were filled in using rubble. Source: PORR

Once work to install the road surface had been completed and the bridge recommissioned, the arch-supporting scaffolding was dismantled and the arch structures and supporting walls treated with high-pressure water-jet cleaning. The water pressure of 1,200 bar was tested in advance on reference surfaces. In the course of this work and further necessary examinations, cavities were identified in the arches and subsequently filled in using a mortar injection procedure. The natural stone masonry was grouted to a depth of 80mm. The jointing - once again in coordination with specialist heritage officers - was carried out using lime mortar with max. 5% white cement additive for stones made of soft and porous rock and max. 10% for those made of igneous rock. The visible areas of jointing were neither mechanically smoothed nor treated in any other way. Instead, the mortar was coloured with sand to match the natural tone of historic mortar. Any missing or weathered parts of the natural stone masonry were repaired using the resulting rubble, while ensuring the joint distribution remained even.
