# Sedlec-Prčice bridge

09.01.2019 / Česko / Alexandr Herzán

## Renovation of a historic bridge

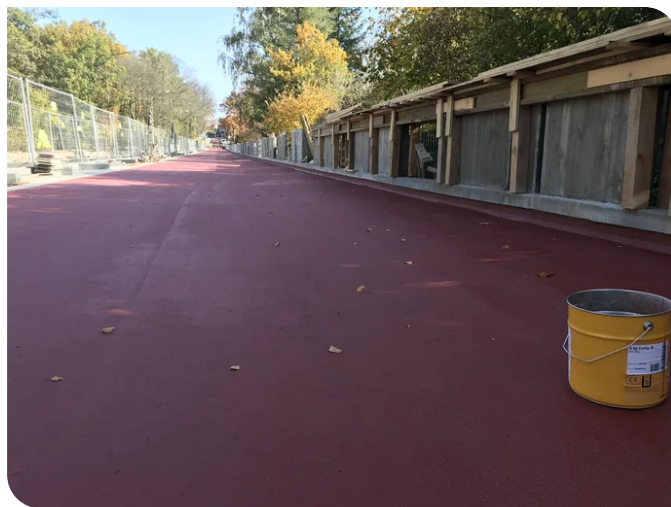
The bridge deck was replaced, as were the historic concrete railings. Source: PORR

Inspections revealed damage to the carriageway, crumbling reinforced concrete railings and heavy water ingress in the bridge structure.

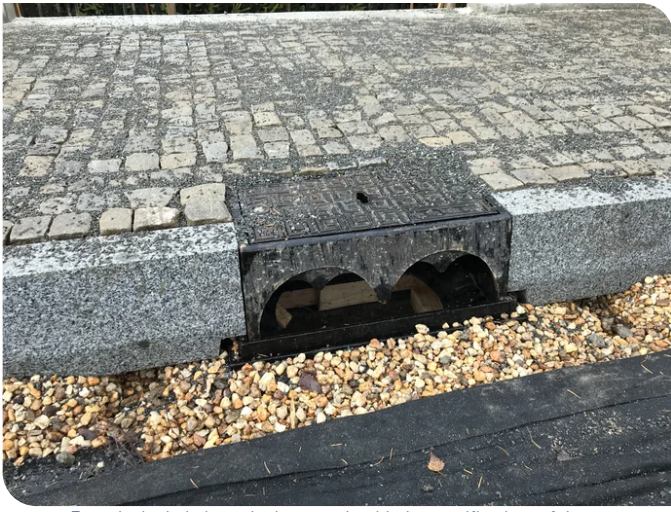
Even the kerb drainage had to comply with the specifications of the monument protection authority. Source: PORR

Following the installation of the waterproofing system, the kerb drainage was installed at 10 metre intervals, which, like the granite gargoyles, had to be approved by the monument protection authority. The same applied to the new reinforced concrete railings mounted on reinforced concrete caps. A prototype of the steel rod infill was also submitted to the heritage authority. PORR constructed a three-layer asphalt carriageway between the kerbs. The pavement structure was designed as natural stone paving in a sand bed with a cross slope of 2.5%.

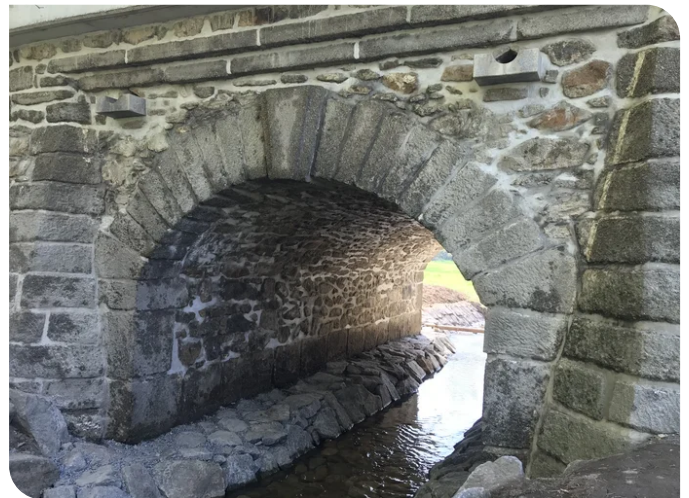
The visible joint surfaces were neither smoothed nor treated in any other way. Missing natural stone masonry was supplemented with quarry stone. Source: PORR

Once the work on the carriageway surface had been completed and the bridge put into operation, the arch scaffolding was dismantled and the arch structures as well as the retaining wall were treated using the high-pressure nozzle water jetting method. The pressure of 1,200 bar was tested in advance on reference surfaces. During this work and the additional necessary investigations of the structure, caverns were discovered in the area of the back of the vault, which were filled using the mortar injection method. The natural stone masonry was grouted to a depth of 80 mm. This grouting was carried out - again in consultation with the conservationists - using a lime mortar with a maximum of 5% white cement additive for soft and porous stone types and a maximum of 10% for igneous stone. The visible joint surface was neither mechanically smoothed nor treated in any other way. Instead, the mortar was discoloured with sand in the natural colour of the historical mortar. Missing or weathered natural stone masonry was supplemented with the exposed quarry stone, taking into account the joint distribution.
