# The Loftesnes Bridge

## Civil engineering/ Infrastructure

## New landmark in the heart of the Norwegian fjords

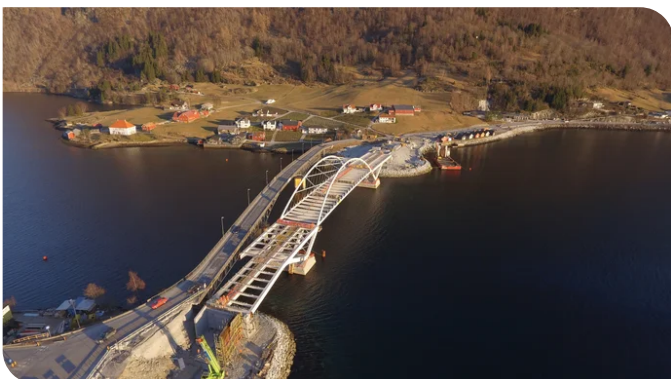
In addition to the construction of the new bridge, the contract also included the construction of a roundabout and the demolition of the old bridge. Source: PNC Norge AS Until

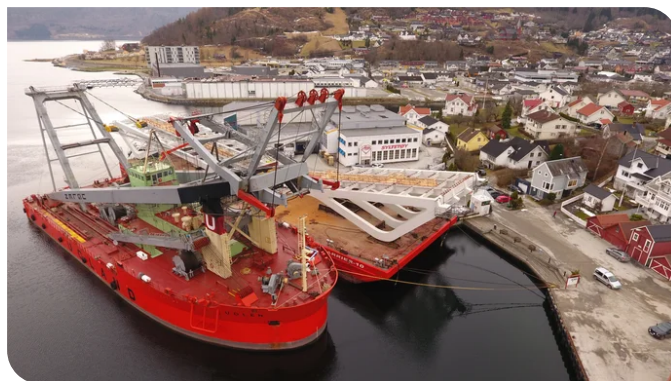
The first barge transported two bridge sections to the local quay near the construction site. The 800 tonne floating crane was also already on site at this time. Source: PNC Norge AS

The arrival of the steel structure and the subsequent bridge installation marked the start of the most exciting phase of the project, which was also met with great interest by the local population. Local residents and onlookers gathered on the quay where the steel structure was placed to watch the construction process. For the installation itself, PNC had precisely defined each work step in advance and drawn up a detailed schedule. A floating crane with a lifting capacity of 800 tonnes was used to assemble the three bridge sections. The first steel structure, weighing 470 tonnes, was suspended from the crane and installed in its final position on 31 January. Just four days later, the other two sections were also in place. As one section was assembled very close to the old bridge, traffic had to be closed for a short time for safety reasons.
