**PROGRESS: 100% - COMPLETED**  
CZECHIA/SEDEC UND PRČICE/2017-18

## RENOVATION OF A HISTORIC BRIDGE

### Sedlec-Prčice bridge

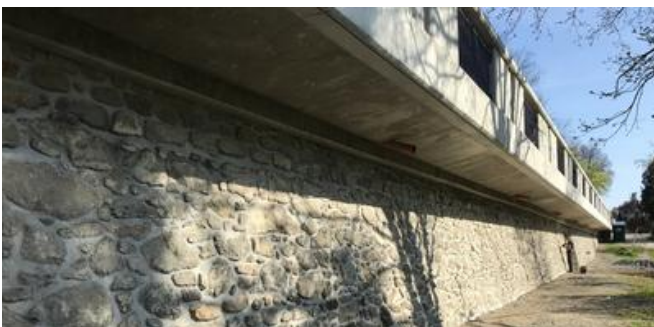
The bridge's foundation is made up of natural stone masonry. Source: PORR

The final part of the restoration work involved replacing the paving on the floodplain and the paving beneath the bridge. The base of the bridge was also consolidated to prevent the parts of the arches that had been filled in and the abutments from being worn away by standard water flows. Some 3m of paving was laid upstream of the bridge as well as 3m downstream and in the entire riverbed beneath the bridge. The entire area covered by the stream during flooding was also cleaned up. Concrete sleepers were used to pave the riverbed.
