# D2 motorway restoration in the Czech Republic

## Civil engineering/ Infrastructure

**Scope:** Complete restoration of a 9km-long section of the D2 motorway

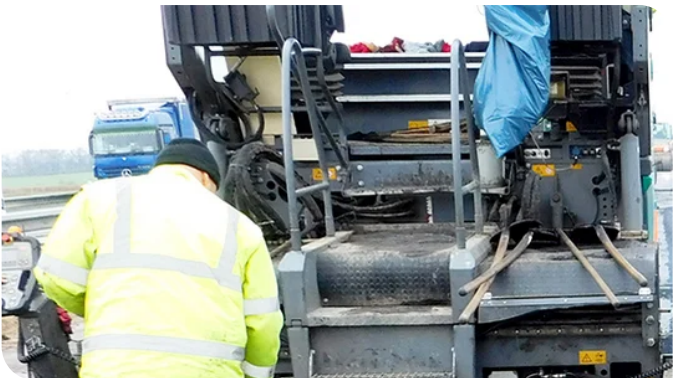
RB 500 resonance crusher - construction machine for demolishing the concrete substructure. Image: PORR AG

During the first step, the existing roadway surface was rubblised with a resonance concrete breaker. This proved to be an efficient and effective measure for removing the concrete slabs. This construction machine, model RB 500, was able to literally crush the existing cement concrete in a short period of time, operating at higher frequency (55Hz) and lower amplitude (19mm). Some 18,000m<sup>3</sup> of rubble was accumulated in total, which was later recycled into the new construction.
