# Brasov International Airport

## Civil engineering/ Infrastructure

**Scope:** Construction of a taxiway, apron and rainwater drainage system

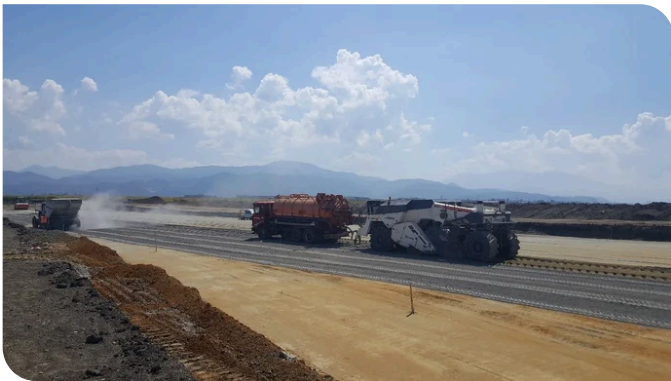
A 25cm thick stabilised ballast layer was laid on top of the lower ballast layer for the taxiway and apron. Source: PORR Construct

The next stage of the structural work for the apron and taxiway was to create a 40cm thick ballast base course. A further 25cm thick course of stabilised ballast was then laid on top of this. Cable ducts were incorporated into the stabilised ballast, so that the power supply cables for the taxiway lights could be laid in the ground. The shoulder was constructed from a base course consisting of 35cm thick ballast beneath a 25cm course of stabilised ballast.

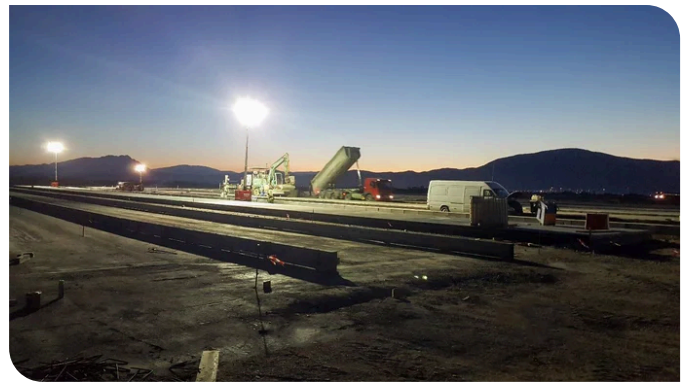
Solid steel girders were used as formwork for the concrete layer. Source: PORR Construct

Solid steel girders were used as formwork for the concrete layer. The project was particularly challenging due to the short construction period, which meant that work had to be done around the clock, including weekends.

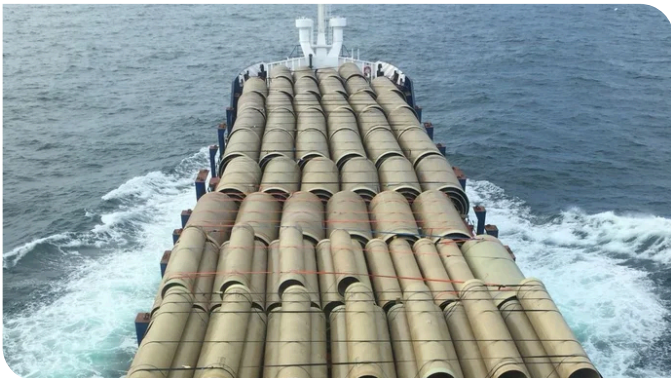
The pipes for the rainwater draining system were delivered from Turkey on two ships. Source: PORR Construct

In just two months, 12km of GRP pipes (DN 500–DN 2000) were manufactured in Turkey and delivered to Romania for the rainwater drainage channels. They were transported to Constanta by two ships and then transferred onto a total of 223 lorries. The first transport had to include every type of pipe, so that work could begin immediately. This was made possible by the collaboration with the excellent delivery contractor APS, who was also responsible for delivering the GRP manholes and concrete manholes.

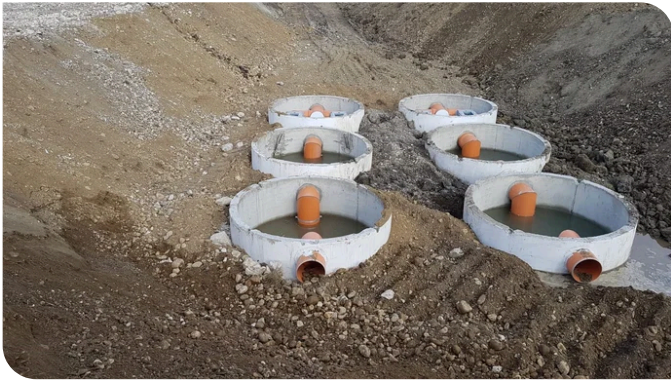
Water is cleaned in the two-stage oil separator system. Source: PORR Construct

The water collected in the drainage network is transported through the GRP pipes to two oil separators that remove impurities from the water. Each separator has a capacity of 440l/sec and there is also a bypass with a capacity of 1,200l/sec.

Installing the oil separators was a significant challenge due to the high groundwater level: we hit water after just one metre of excavation and had to pump it away continuously. A 15cm ballast layer was installed after the required depth was reached. A concrete course, also 15cm thick, followed. Once the separators were in place, the filling began with layers of 20cm thickness of soil, reaching the top sections of the separators.

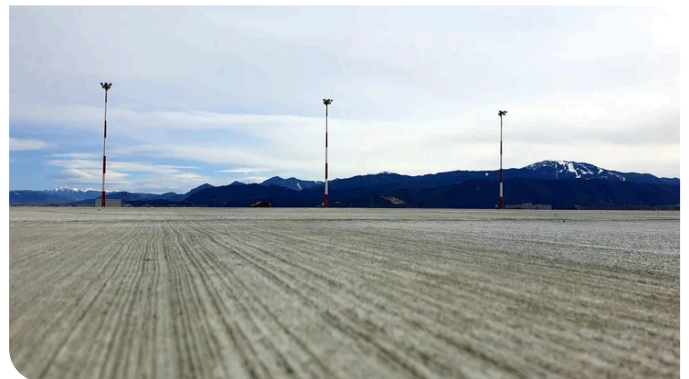
PORR built a high-mast lighting system at the edge of the platform. Source: PORR Construct

The final part of the work was to install the lighting system: three 28m light masts. Each mast has four LEDs, a control panel and a lightning conductor. The foundation is 2.4m high and includes all necessary cables and ducts. It is made of class C30/37 reinforced concrete.
