# Renovating the Hochmais and Frauenegg anchor walls

## Civil engineering/ Infrastructure

**Scope:** Drilling anchor holes and  
fabricating pilaster strips

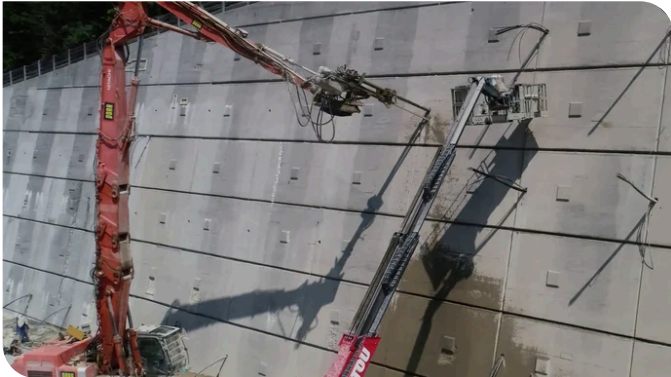
A 60t excavator with carriage attachment was used for drilling at heights of up to 20m. Source: PORR Specialist civil engineering

When the anchor walls were constructed in the seventies and eighties, the slopes and valleys were cut into step by step, and anchored on each new level using crawler drill rigs. Now, however, the anchoring work would need to be done at heights of up to 20m – a fresh challenge. Special equipment would be required to install the anchors as planned.

PORR installed the new anchors on the 25m high Hochmais anchor wall at three levels. The bottom level was installed using a crawler drill rig, while a 60t excavator with a carriage attachment on its arm was used to drill the anchor holes in the higher levels at heights of up to 20m. The mechanical installation followed safely using an anchor dispenser. Altogether, 167 permanent strand anchors were installed on the Hochmais anchor wall – 4,615m of anchors in total. The individual anchors are up to 36m long with a breaking load of 2,790kN.

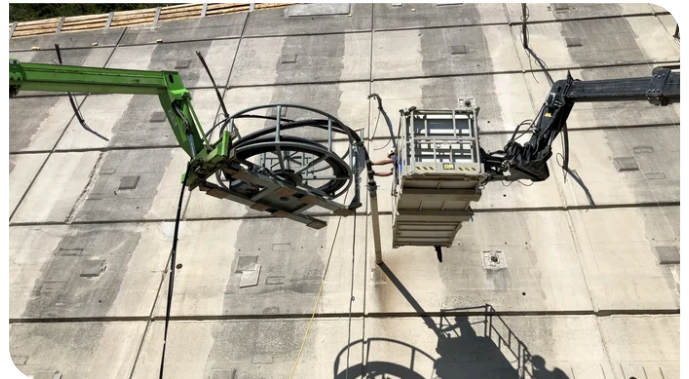
Altogether, 167 permanent strand anchors were installed on the Hochmais anchor wall, making 4,615m of anchors in total. Source: PORR Specialist civil engineering

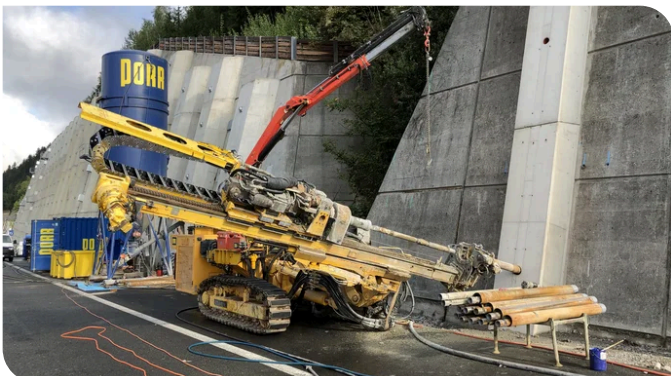
The drill holes in the lower level were drilled using a crawler drill rig. Source: PORR Specialist civil engineering

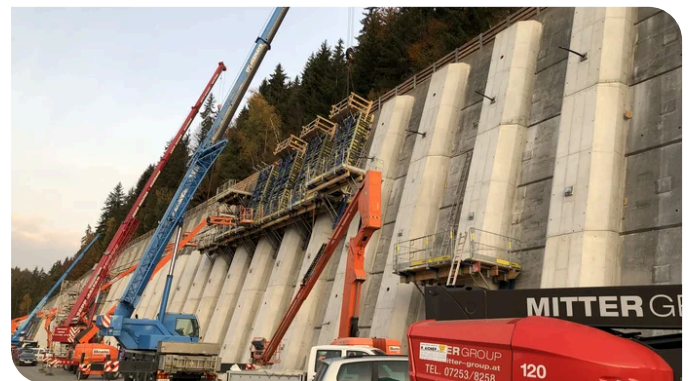
The pilaster strips on the anchor wall were concreted after the anchor holes had been drilled. Source: PORR Specialist civil engineering

The PORR team used a double rotary drilling procedure. In this procedure, two separate rotary drives are used to drill the casing and auger into the bedrock. The casing supports the drilled hole, while the auger, tipped with the boring head, travels slightly ahead to rotate and break up the bedrock. The loose material is then flushed out of the drilled hole with air and water. In the 'right-left' system, the casing rotates anti-clockwise and the auger clockwise to ensure a good drilling performance. Once the anchors had been installed, the drill holes were filled with cement grout. The following day, the grout was injected into the bond using a high-pressure process. This holds the anchor in the bedrock. The grouting process was repeated until the required retaining pressure was reached. The vertical pilaster strips on the Hochmais anchor wall were concreted after the anchor holes had been drilled; on the Frauenegg wall, some were concreted beforehand. In order to ensure that the pilaster strips had sufficient concrete strength to prestress the anchors, it was essential to wait the full hardening time.

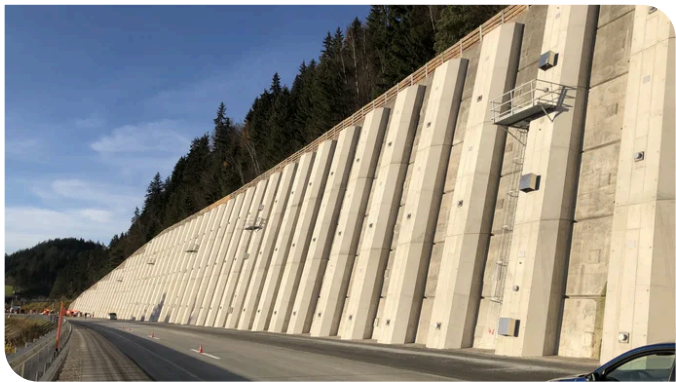
Regular monitoring of the anchor walls is facilitated by fifteen measurement cross-sections, fitted with 32 force plates and 25 extensometers. Source: PORR Specialist civil engineering

Measurement cross-sections were built to facilitate continuous monitoring of the anchor walls. Force plates were installed so that potential changes to the anchor forces can be identified quickly, while extensometers measure any movement in the walls. Six measurement cross-sections were built in the Hochmais anchor wall, comprising seventeen force plates and twelve extensometers, with a total length of 410m. The Frauenegg anchor wall has nine measurement cross-sections comprising fifteen force plates and thirteen extensometers, with a total length of 350m.
