**PROGRESS: 100% - COMPLETED**  
AUSTRIA/TRAUNSEE/2017-18

## TURNKEY TRAINING CAMPUS

### Traunkirchen Forestry Training Centre

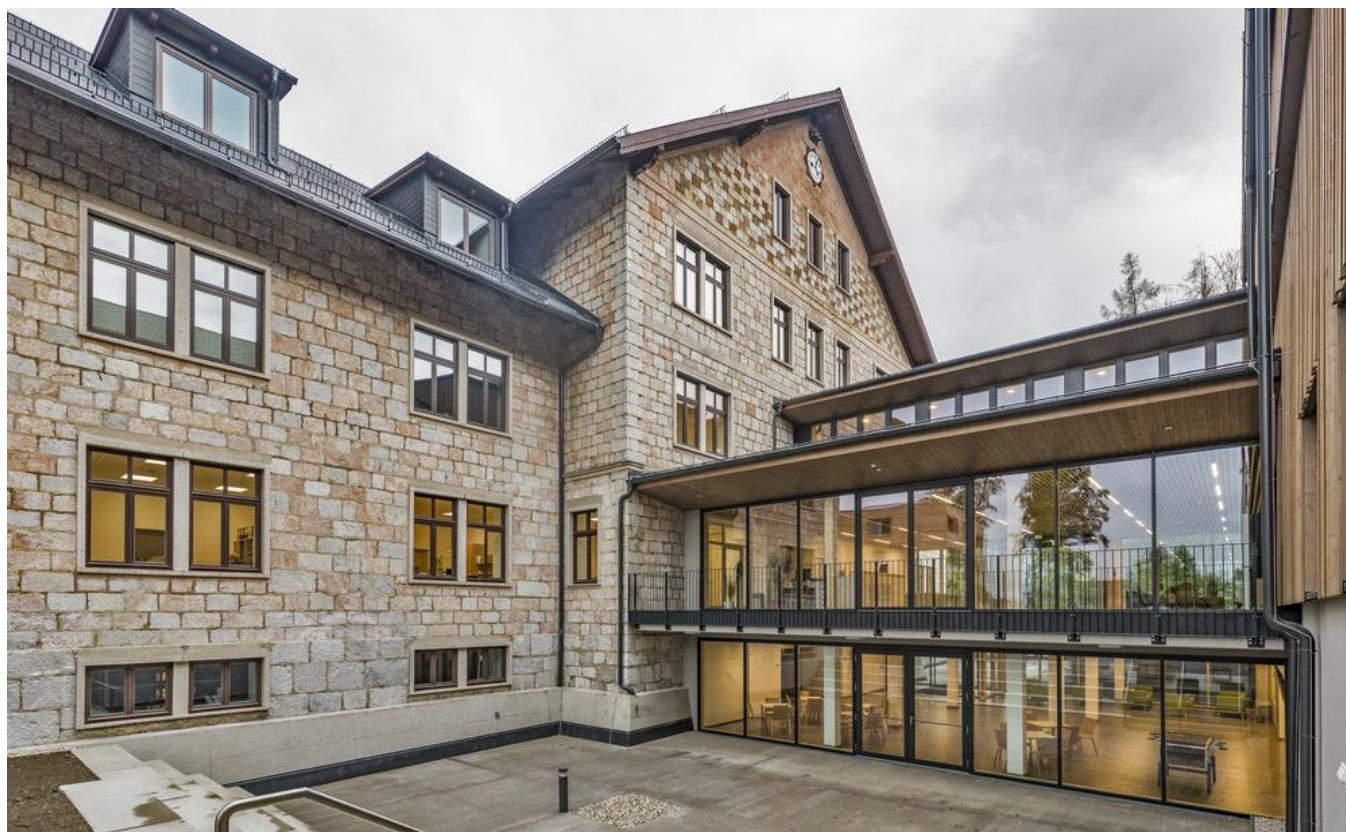
Glazed walkways link the heritage-listed hunting lodge to the newly-built school and residential buildings. Source: Gerd Kressl

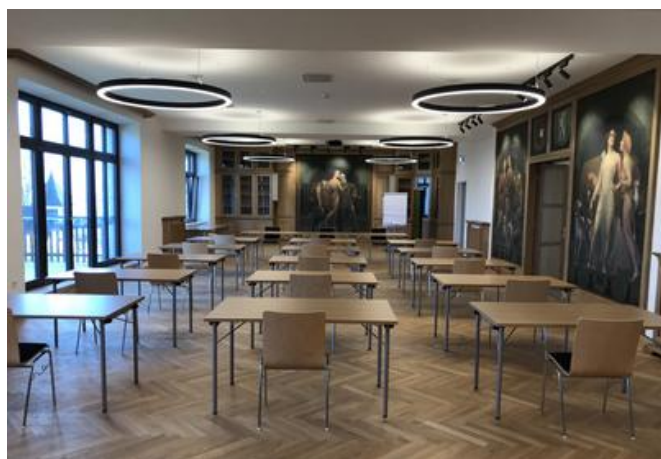
Tradition meets modernity in the dining hall located in the converted hunting lodge, now an administration building. Source: Gerd Kressl

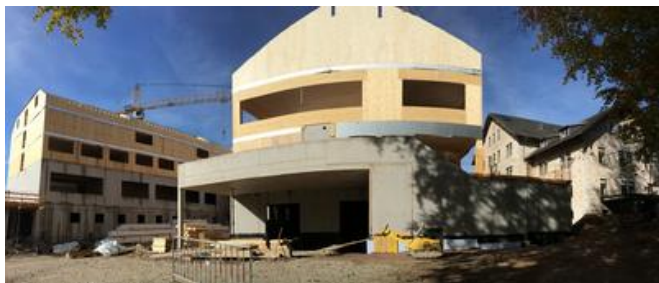
Two weeks later: work begins on the roof truss. Source: Gerd Kressl

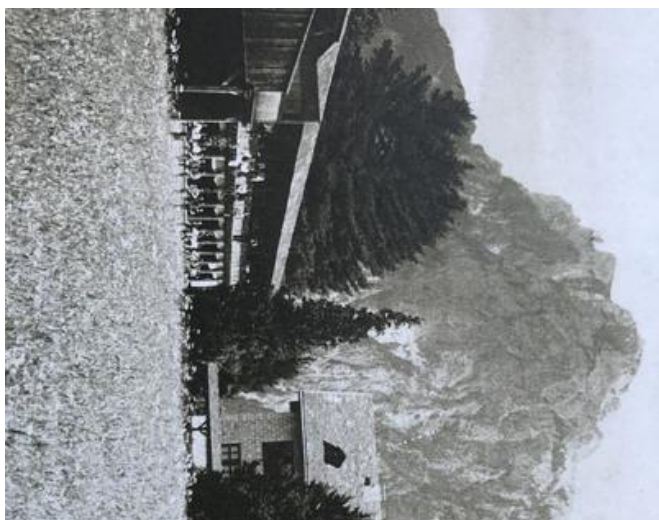
The former hunting lodge was the home of the Buchberg state hospital from 1921 to 2009. Source: Forestry Training Centre

The former hunting lodge has been adapted to a number of uses over the years. Back in the 1920s, for example, the villa was sold by the owners to the State of Upper Austria, and transformed into a lung sanatorium. Between 1973 and its closure in 2009, the building served as a special hospital for non-specific respiratory tract complaints. To prepare the heritage-listed building for its new role as an administrative building, a complete overhaul and conversion was – once again – necessary. During this process, the client attached particular importance to preserving the old structures. PORR removed the old asbestos fibre-cement tiles from the roof and replaced them with a new non-toxic double roof covering. The existing roof trusses had to be professionally overhauled, and all the original hand-cut rafters and purlins retained. Preservation of historical monuments also dictated that the windows should be replaced with wooden windows modelled on the originals.

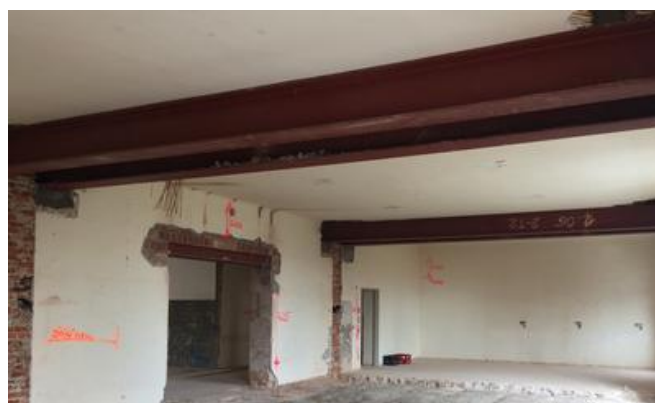
Internal supporting walls had to be removed from the large dining hall and the ceilings underpinned with steel beams. Source: PORR

An unpleasant surprise met the PORR workers when they exposed the old wooden ceilings: various damages meant compliance with the relevant norms was impossible. Additional timber had to be incorporated into all the ceilings. In addition, all the gaps in the original Traunstein marble facade had to be supplemented with original material, and the facade restored to its original condition; a clock on one of the gables also needed renovation, and in addition to the above-ground work, all the drainage systems and underground pipes in the cellar were brought up to date. All covered components were fitted with fresh seals and perimeter insulation. An old arch, exposed during the renovation work, is now a feature in the newly-built bistro. Internal supporting walls on the second floor had to be removed and the ceilings underpinned with steel beams before the large dining hall could be created as required. An external emergency stairwell was built on the north side, as specified by the authorities.

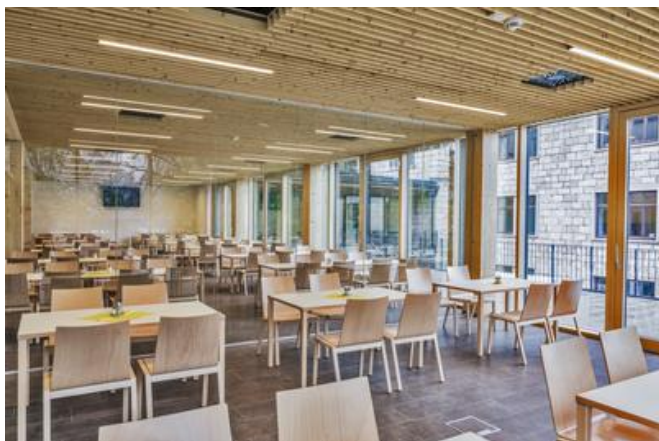
Timber is the main construction material used in the canteen.  
Source: Gerd Kressl

As a forestry training centre, the new training campus aims to stress sustainability. Consequently, timber had an important role to play as a construction material. Both the school and residential blocks were largely built based on timber structures. Where fire protection permitted, wood was also used for the walls and surfaces. Sample tests of the wooden facade and its rear ventilation were carried out at a 1:1 scale on site, inspected and approved by the architect. The wooden facade and windows have been optimised for insulation quality. The roof areas are being used to generate solar electricity. Heat is supplied from a biomass power station. The multipurpose hall and server rooms are cooled by means of heat density cooling together with the use of a spring located on the grounds. In the spirit of the klimaaktiv building standard, electric vehicle charging points have also been installed, along with bicycle stands.

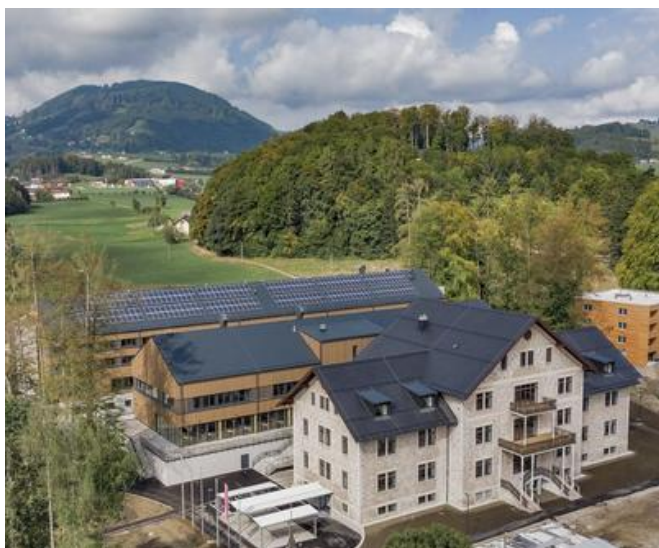
The original building is in the foreground; behind it can be seen the new timber buildings with solar panels on the roof. Source: Gerd Kressl

The innovative and thermally high-quality building envelope, coupled with state-of-the-art efficient building technology and the 123 kWp solar system, represents an important foundation element for the klimaaktiv “Gold” certificate. PDE supported this aspect of the project from the initial contract award through to the inauguration of the Centre. Initiatives such as building project management and optimisation of the energy technology across the entire project meant that PORR could act as a “one-stop shop” to meet all the customer’s requirements. The subsequent quality assurance was carried out via various measurements, e.g. airtightness in the spaces, quality of the air inside and sound insulation. Great collaboration between the construction site and PDE ensured that the klimaaktiv Gold Standard was achieved without significant additional effort for the contractor or extra costs for the client.
