READY FOR TAKE-OFF

08L-26R Runway Henri Coanda Airport Bucharest

Within just five months, PORR Construct has modernised one of the country's most important runways at Henri Coanda International Airport in Romania, Bucharest.

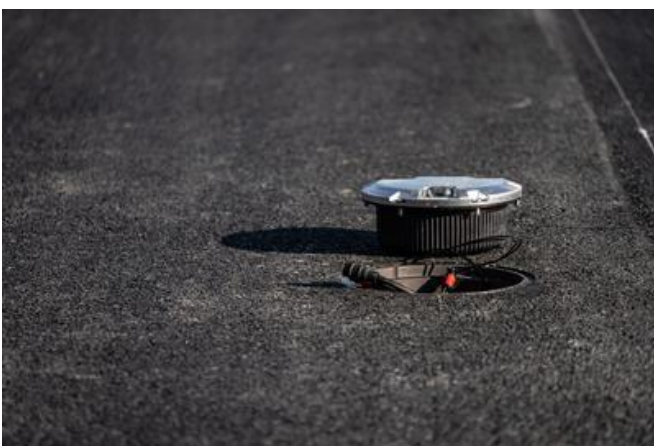
PORR replaced all beaconing lamps on the runway. Source: PORR

The visual aids system for navigation was designed and executed to comply with all regulations for a category III Precision Approach Runway in both directions. The team replaced all the primary and secondary circuits mounted in protection pipes, the aeronautical beacons for the runway threshold, end, centre and touchdown area, the approach system, the stop bar along with all signs and markings. In addition, the tower remote control has been upgraded.

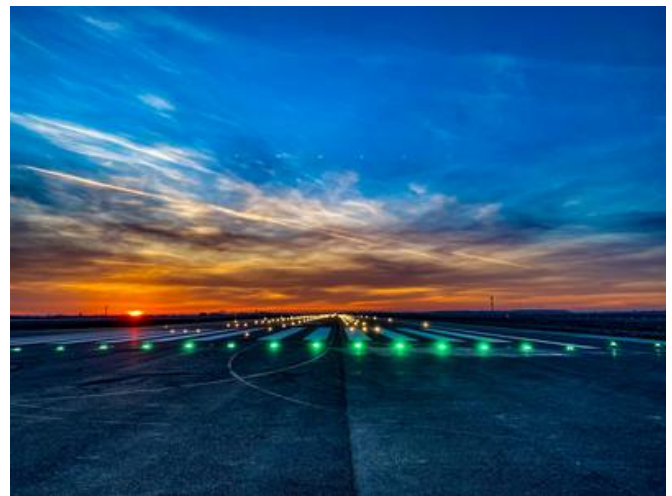
The newly installed beacons illuminate the finished runway. Source: PORR
